Westside Home Inspections

RESIDENTIAL INSPECTION REPORT

Date of Inspection: 2/28/2021 Time: 12:00 PM

Age of Home: 1962 Size: 1875

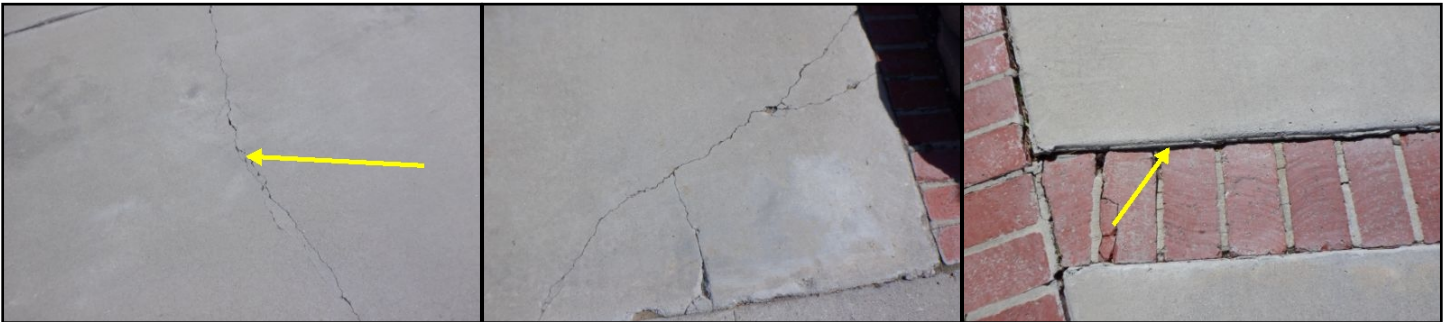
2.1. Common fracture cracks observed in the , primarily a cosmetic concern. I suggest sealing all concrete slab joints as well as any cracks in concrete/asphalt/brick surfaces to prevent water penetration as a routine maintenance effort.

2.2. Heaving observed on some sections of the walkway. This is a trip hazard; recommend re-leveling or replacing.

Cracks on driveway

Trip hazard

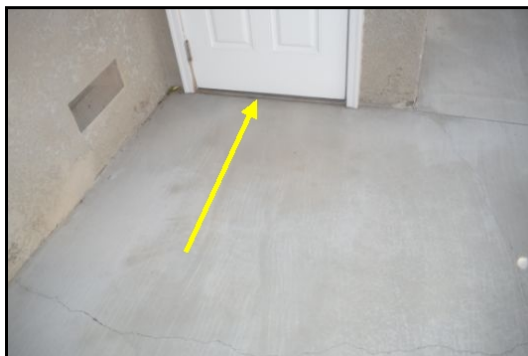
3.1. Low area was observed at garage exterior door. Recommended monitoring after heavy rain to ensure proper drainage away from the structure at all times.

Low areas observed

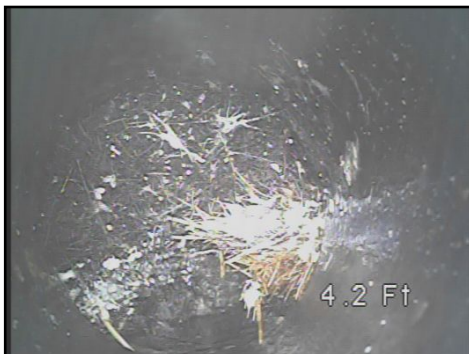
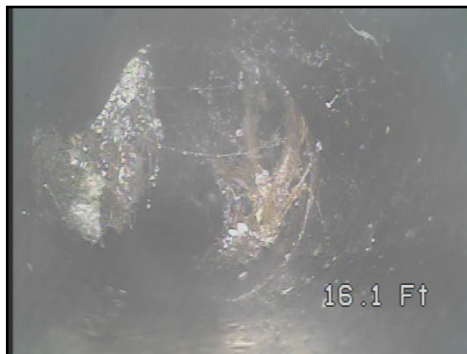
8.1 Root Intrusion was observed at the time of the scope inspection. Recommend further review from a qualified contractor to repair or replace affected sections of the sewer line. See attached pictures.

Root Intrusion

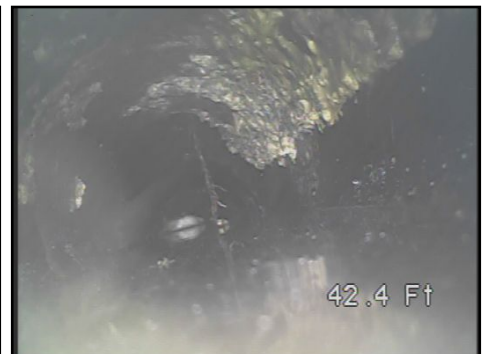
8.2 Possible bellies or settling pipes at the time of the scope inspection. Camera when under water in one or more section of the main sewer pipe. Recommend further review from a qualified contractor for possible repairs.

Possible bellies or settling pipe

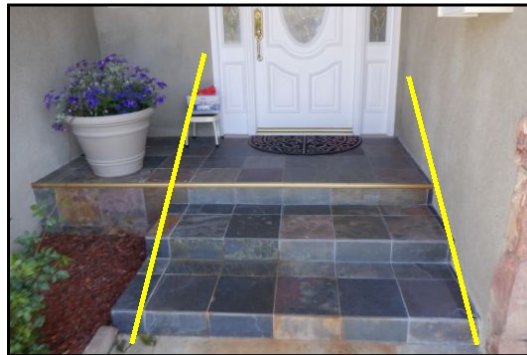
2.2. Stairs with more than two risers have no handrail installed. This is a safety hazard. Installation of graspable handrails that your hand can completely encircle at stairs are recommended, and as per standard building practices.

No handrail more than 2 risers

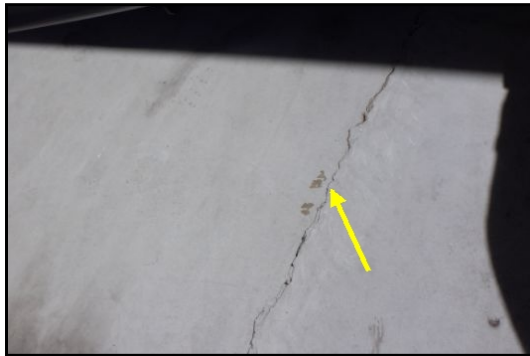
1.2. Common cracks noted at the time of the inspection. Cracking is a common occurrence at concrete surfaces. Cracking that is not sealed will allow further deterioration as water expands and contracts. Sealing the cracks to prolong the life of the concrete would be advised.

Common cracks

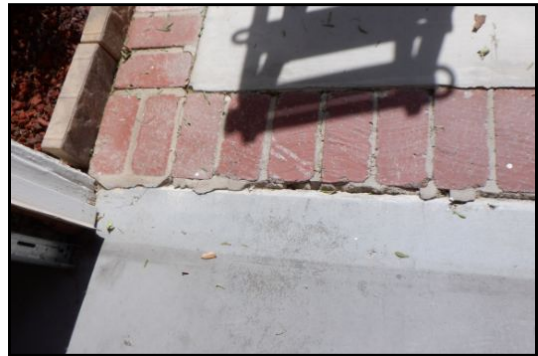
1.1. Garage floor was lower at the garage and driveway transition. Water can intrude into the interior of the garage. Recommend monitoring this area after heavy rain.

Garage floor lower at driveway

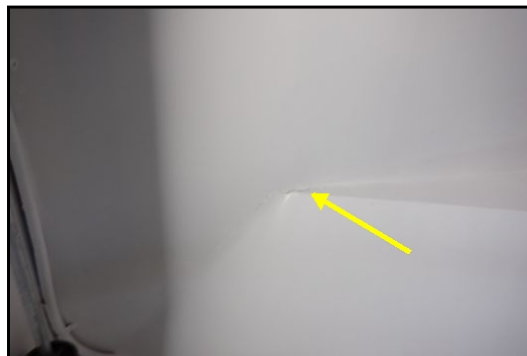
2.1. Small cracking on ceiling was observed at the time of inspection. Does not appear to be a structural concern, but the client may wish to repair these for aesthetic reasons.

Small cracks

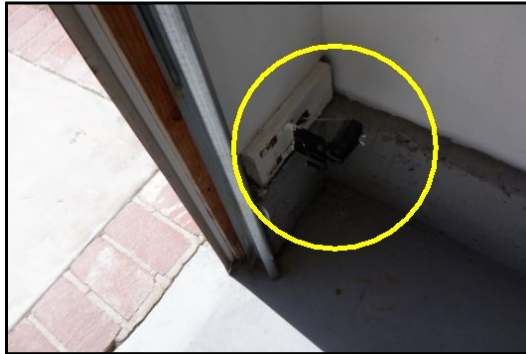
4.2. The photo sensor was installed at a height greater than 6 inches. Safety standards designed to protect small children limit the maximum mounting height for garage door photo sensors at 6 inches.

Sensor higher than 6 inches

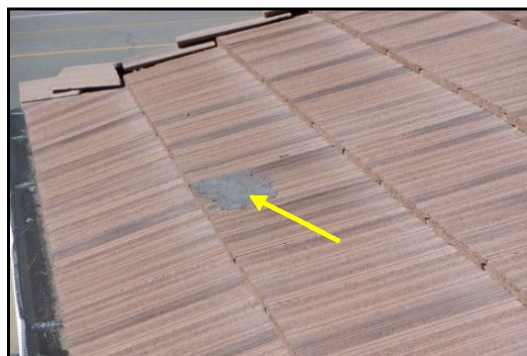
2.1. Evidence of roof repairs observed at the time of inspection, unable to determine the effectiveness of these repairs.

Roof repairs

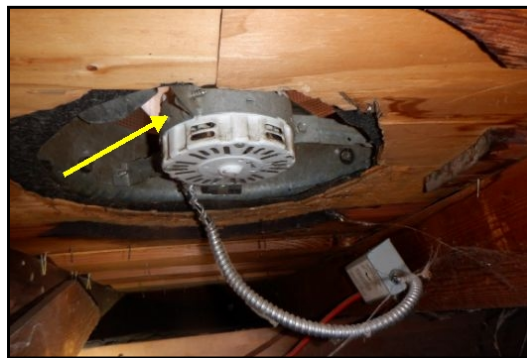
3.2. **The attic fan controlled by a thermostat was inoperable at the time of inspection. Recommend review for repair or replacement as necessary. See attached picture.**

Inoperable fan noted

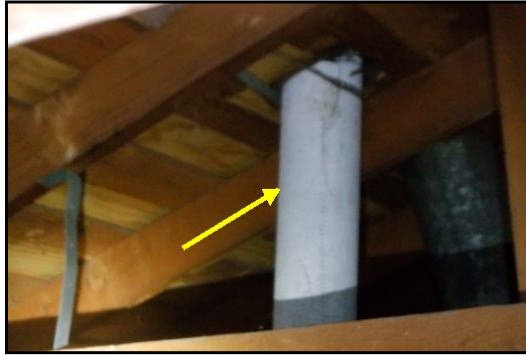
Possible asbestos materials observed. The materials appeared to be in serviceable condition at the time of inspection. Asbestos materials are considered safe by the EPA if they are not disturbed, torn, ripped, or damaged. No torn, ripped, or damaged materials were observed. If client has any concerns regarding asbestos materials, an asbestos testing lab should be consulted for further review to ensure safety.

Possible asbestos materials

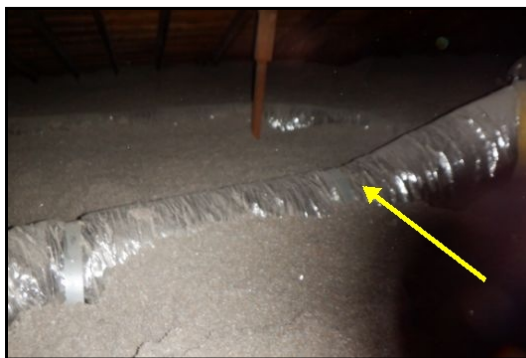
5.2. Duct work was lying on the insulation or ceiling joist in the attic at the time of the inspection. Current standards now require the ducts to be properly suspended from the rafters above the insulation at intervals no greater than 5' and the hanger material should be at least 1 1/2" wide so it doesn't reduce the internal diameter of the duct. Recommend correction for proper airflow.

Duct work lying on ceiling joist

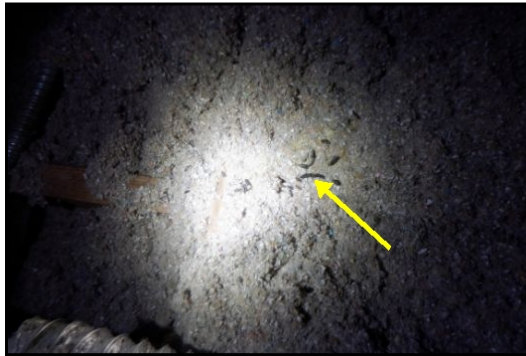
6.2. Vermin activity or rodent drops was observed in the attic insulation at the time of inspection. Vermin can damage insulation & electrical wiring. Recommend a professional pest contractor evaluate for treatment.

Vermin activity

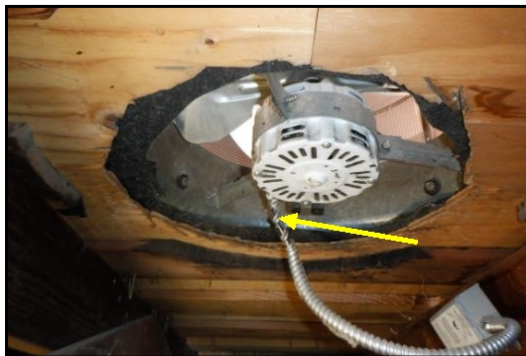
7.2. Metallic sheathed wiring for the mechanical ventilation fan was subject to damage. This is a safety hazard due to the risk of shock and fire. Recommend correction. See attached picture.

Damaged metallic sheathed

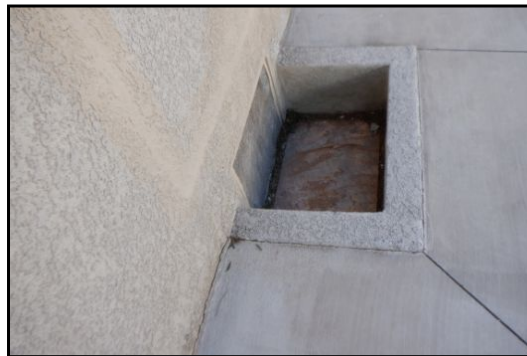
2.1 Concrete curb was not installed in crawlspace access to divert runoff water from entering the crawlspace. Moisture can damage home materials and encourage the growth of microbes such as mold.

No concrete curb

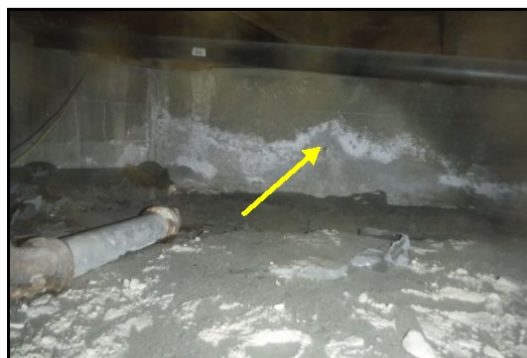
3.2. Efflorescence (white powdery deposits) visible on the inside surfaces of the foundation walls in the crawlspace is an indication of moisture intrusion. Moisture intrusion can affect the ability of the soil beneath the foundation to carry the weight of the structure above and may cause structural damage from soil movement. Moisture intrusion can also damage home materials and encourage the growth of microbes such as mold.

Efflorescence on foundation wall

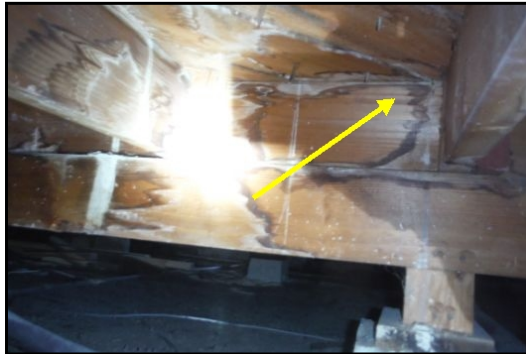
6.1. Some dry past water damage/stains near joists especially around bathroom area plumbing was observed at the time of the inspection. No active leaks were discovered at time of inspection. See attached pictures

Evidence of dry past water damage

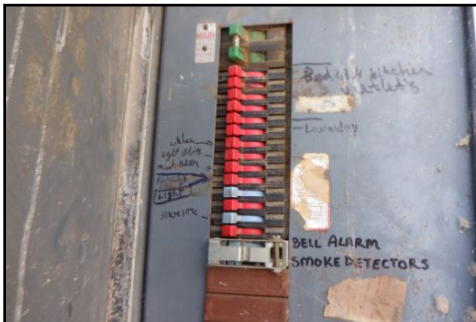
Partial labeled

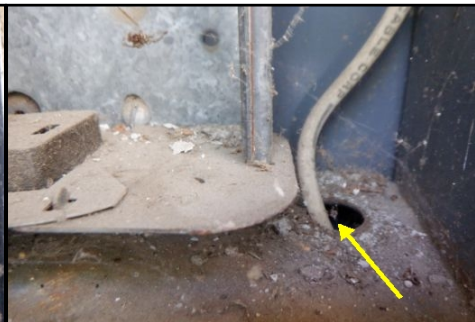
No bushing installed

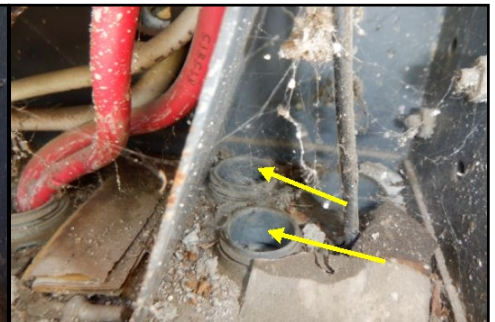
4.4. Knockouts have been removed inside the main panel where no wires and bushings are installed at the time of inspection, and no cover have been installed to seal the hole. This is a safety hazard due to the risk of fire.

Open Knockouts

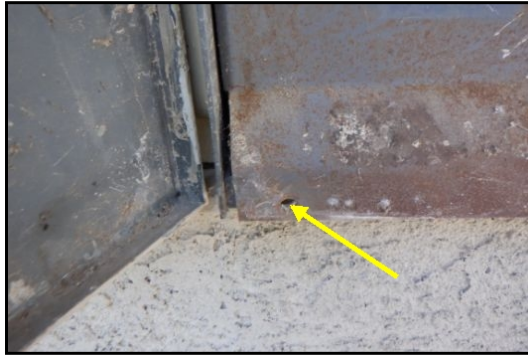
4.5. The dead front cover of the main panel was missing screws at the time of the inspection. They should be replaced for safety.

Missing screws

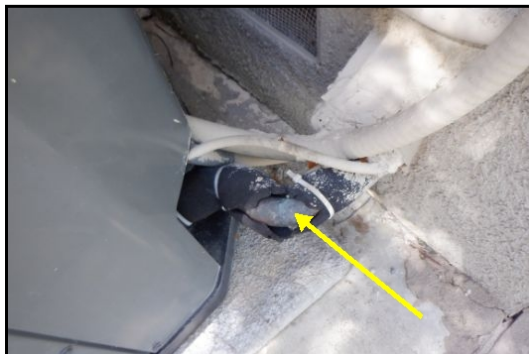
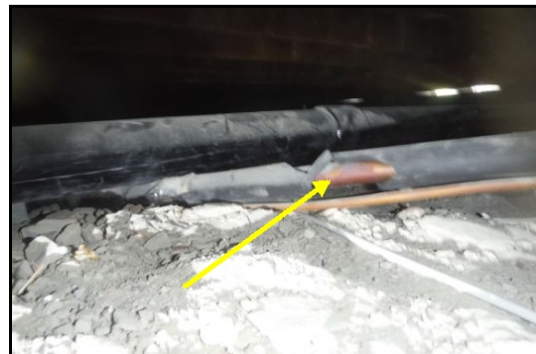
3.2. Insulation on the air-conditioning condenser refrigerant line was damaged or missing at the time of inspection in areas and should be replaced.

Missing/deteriorated refrigerant line insulation

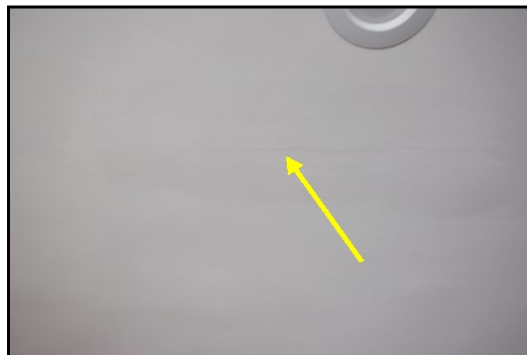
2.1. Freshly painted areas in bedroom #1 at the time of inspection. This could be concealing a defect that could not be determined.

Freshly painted areas

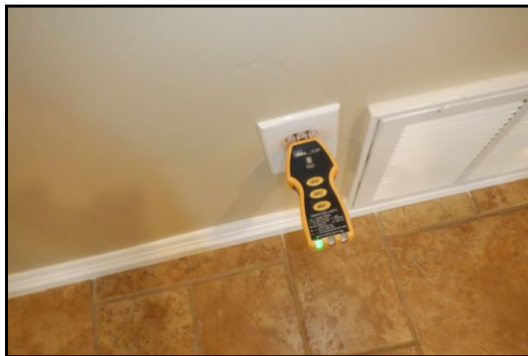
4.2. Open ground (or 2-wire) outlet were present in different areas of the home at the time of the inspection. This means that the 3rd (round) part of an appliance plug is not getting ground protection. This may be a concern with items such as computers and electronic devices.

Open ground outlet/GFCI

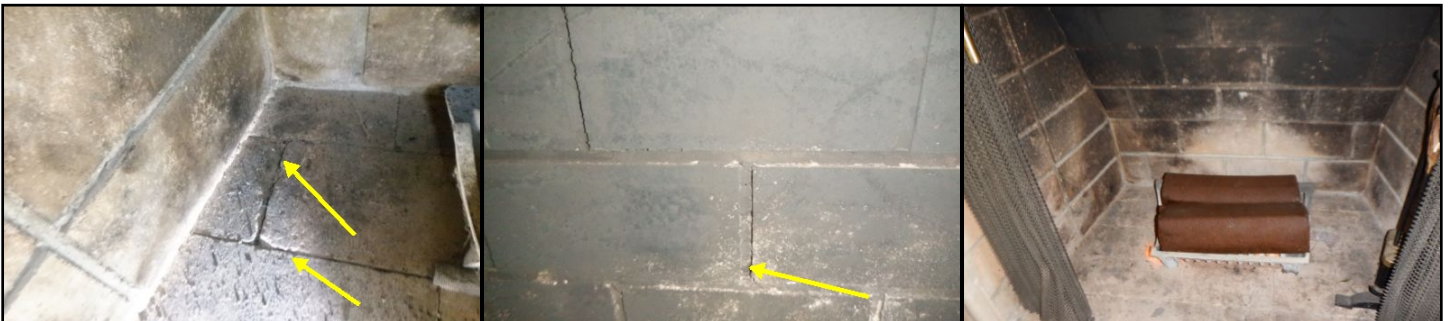
Deteriorated mortar

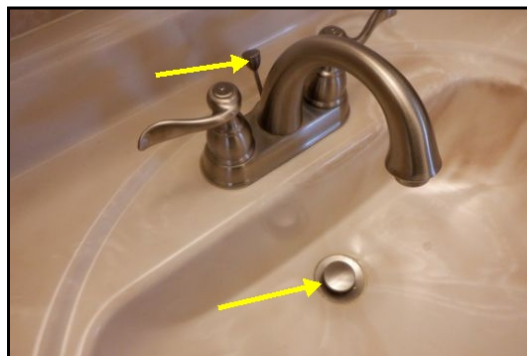
2.2. Sink stopper mechanism was not working in hall bathroom at the time of inspection. Stopper mechanisms should be installed where missing and/or repairs should be made so sink stoppers open and close easily.

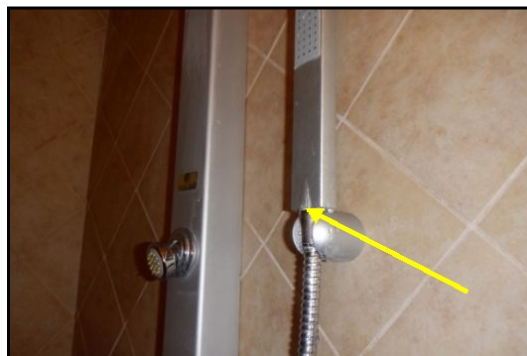
3.2. The shower spray wand was leaking when the shower faucet was operated at the time of inspection. Recommend repairs or replacement as necessary.

Leaking spray wand in on position

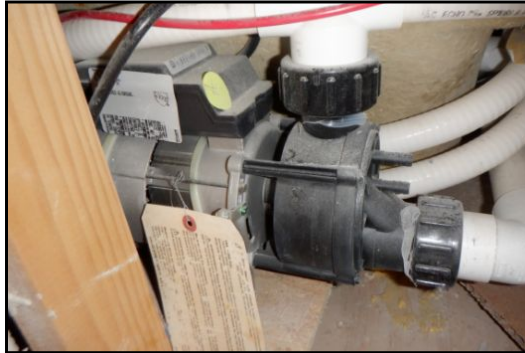
4.2. Whirlpool tubs require GFCI protection to protect people from fatal shock. The GFCI protection was not visible from bath at the time of the inspection. Recommend review by qualified electrician.

GFCI protection was inoperable

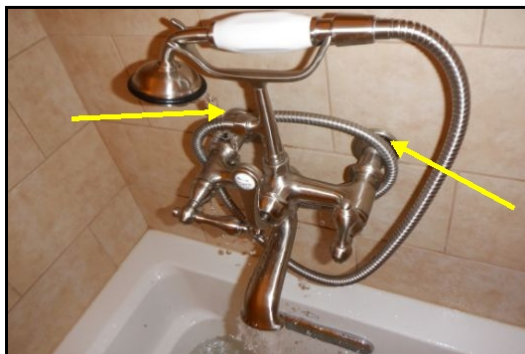
5.2. The whirlpool faucet was loose from basewall in hall bathroom at the time of the inspection, suggest securing as necessary.

Loose faucet from wall

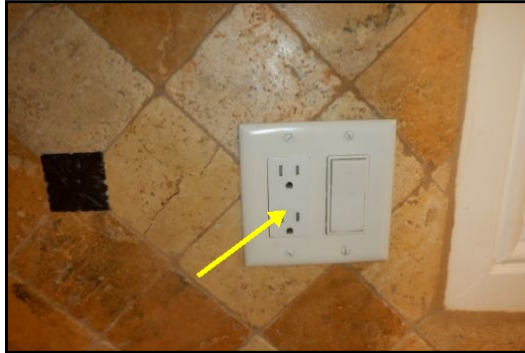
1.2. One kitchen outlet was not GFCI protected. All receptacles located on the exterior of the home, kitchen counter tops, bathrooms, and in the garage are required to be GFCI protected as a safety precaution.

Not GFCI protected
