Westside Home Inspections

Pool and Spa Inspection Report

Inspection prepared for:
Date of Inspection: 2/13/2021 Time: 11:00 AM
Age of Home: 1980 Size: 100

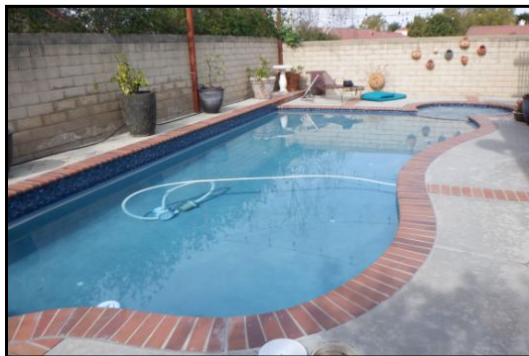
The pedestrian gate on the fence is required to be self-closing, self-latching, only open outwards, not create more than a 4" opening from any structure or 2 inches from the ground and be at least 48" high." (Most communities accept this as their own standards that we observe and comment upon)
 Observations:

No fence

1.1. IMPROVEMENT AND REPAIR RECOMMENDED: It is recommended that a qualified licensed contractor be contacted to further evaluate and repair or replace the following items as necessary:

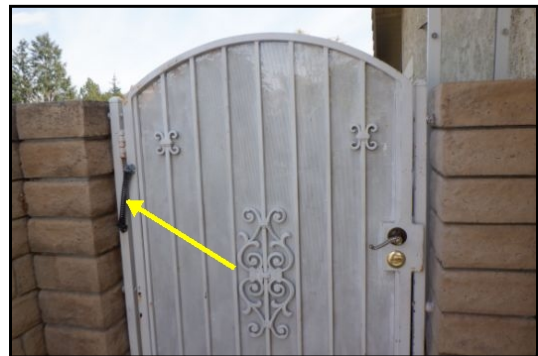
1.2. One or more gates used with pool or spa fencing swung in towards the pool or spa rather than away. Standard building practices require that gates used with pool or spa fencing swing away from the pool or spa.

Gate swung toward pool

1.3. Left side gate did not shut automatically when tested at the time of inspection. Recommend adjusting the spring for proper operation.

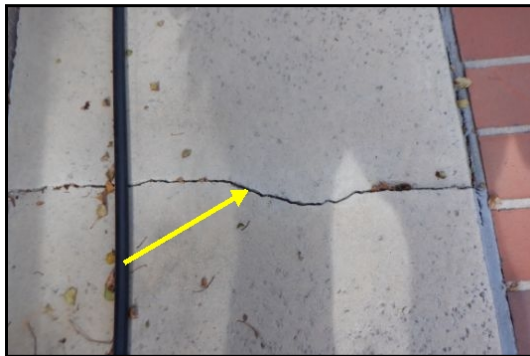
3.2. **Some cracks were found in the decking. Recommend that a qualified person caulk or seal cracks as necessary to prevent water intrusion and further cracking or movement.**

Moderate cracks

3.1. **IMPROVEMENT AND REPAIR RECOMMENDED:** It is recommended that a qualified licensed contractor be contacted to further evaluate and repair or replace the following items as necessary:

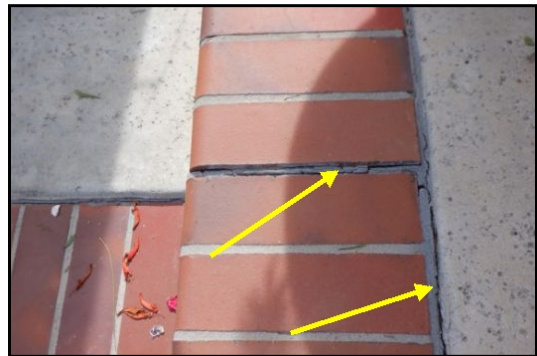
3.3. **The caulking between the pool and spa deck and the coping needs to be either repaired or replaced as soon as possible to prevent water intrusion and damage to the deck and coping.**

Caulk was deteriorated

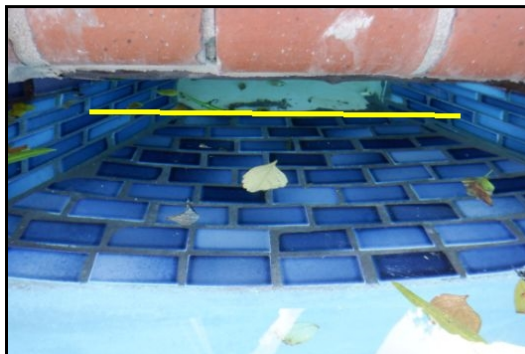
5.2. **The pool skimmer had a missing weir at the time of inspection. Installation is recommended.**

Missing Weir

5.1. **IMPROVEMENT AND REPAIR RECOMMENDED:** It is recommended that a qualified licensed contractor be contacted to further evaluate and repair or replace the following items as necessary:

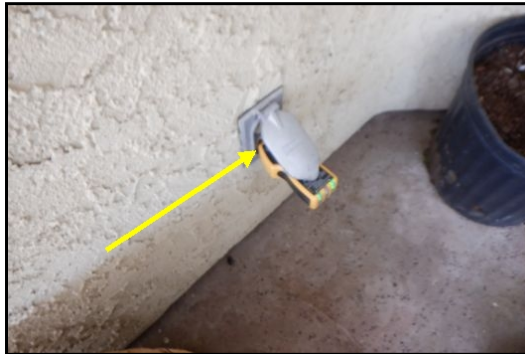
6.2. Outdoor receptacles are not **GFCI** protected, need to be updated for safety.

Not GFCI protected outlet

6.1. IMPROVEMENT AND REPAIR RECOMMENDED: It is recommended that a qualified licensed contractor be contacted to further evaluate and repair or replace the following items as necessary:

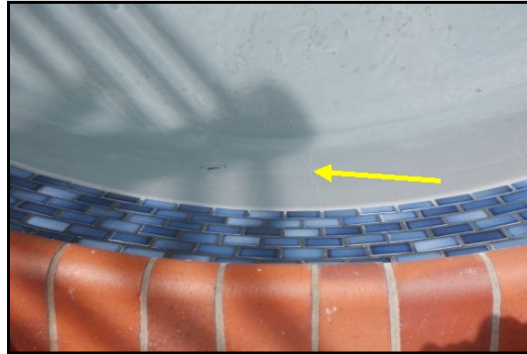
1.1. Plaster on the spa body surface had some line cracks at the time of inspection. Further evaluation of this condition for recommendations for the appropriate repairs. Recommend monitoring cracks for further deterioration.

Small cracks noted

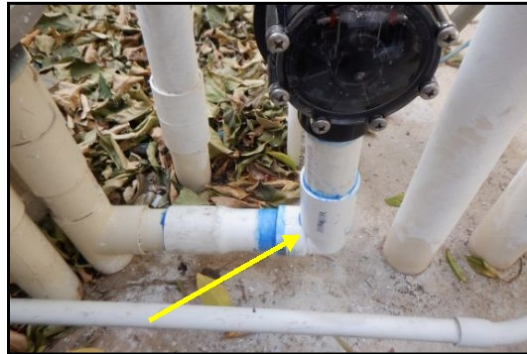
2.2. White plastic **PVC** pipes were exposed to direct sunlight. This type material is deteriorated by the ultra-violet (UV) radiation in sunlight, and this condition will result in premature failure of pipes compared to similar pipes protected from UV. The Inspector recommends that steps (such as painting the pipes) be taken to protect the affected PVC pipes.

Pipes exposed to direct sunlight

2.1. **IMPROVEMENT AND REPAIR RECOMMENDED:** It is recommended that a qualified licensed contractor be contacted to further evaluate and repair or replace the following items as necessary:

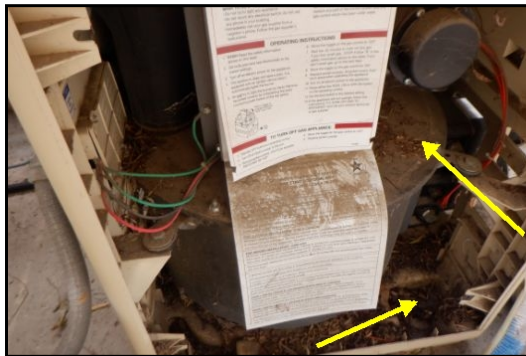
4.3. The pool heater had significant amount of debris inside the unit at the time of inspection. Recommend review for proper maintenance.

Maintenance is advised

4.2. **IMPROVEMENT AND REPAIR RECOMMENDED:** It is recommended that a qualified licensed contractor be contacted to further evaluate and repair or replace the following items as necessary:

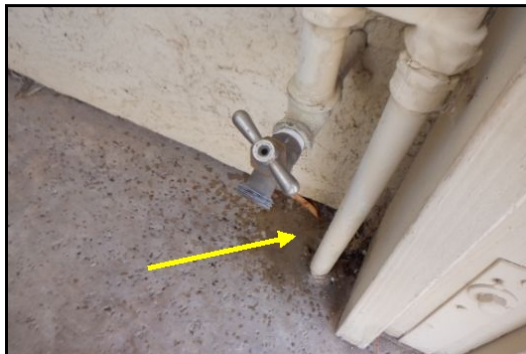
7.2. **Small leak was observed at the time of inspection. Recommend correction.**

Leaking valve noted

7.1. **IMPROVEMENT AND REPAIR RECOMMENDED:** It is recommended that a qualified licensed contractor be contacted to further evaluate and repair or replace the following items as necessary:

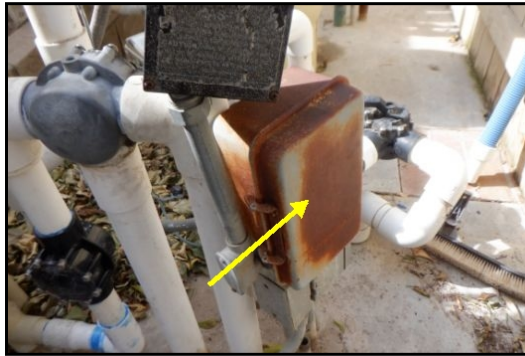
8.2. **The equipment electrical box was corroded at the time of inspection. Not a concern, but it should be painted for protection.**

Rusted electrical box

8.1. **IMPROVEMENT AND REPAIR RECOMMENDED:** It is recommended that a qualified licensed contractor be contacted to further evaluate and repair or replace the following items as necessary:

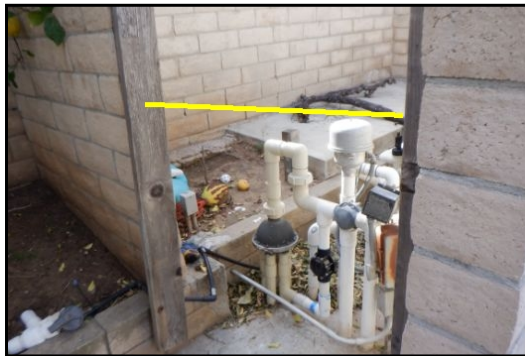
11.2. **The equipment enclosure had missing gates at the time of inspection. Recommend enclosure correction for safety especially for children to come in contact with the pool heater.**

Enclosure unsafe condition

11.1. **IMPROVEMENT AND REPAIR RECOMMENDED:** It is recommended that a qualified licensed contractor be contacted to further evaluate and repair or replace the following items as necessary:
